I. Maintenance Platform/Tool/Equipment Preparation Requirements

1. Working structure of S19 hashboard:

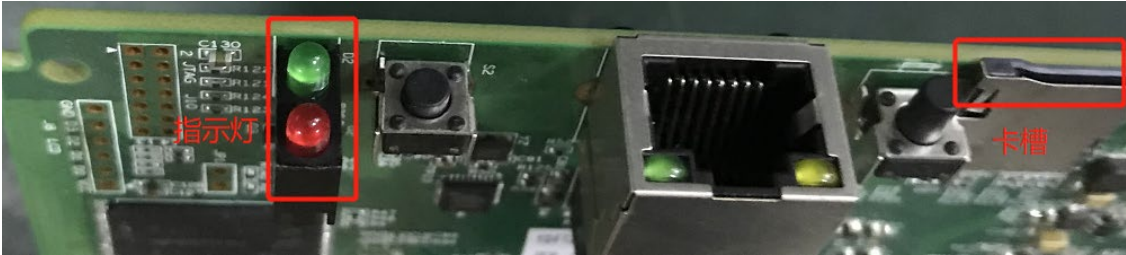
Figure 3-1

- Use the 19 series hashboard tester SD card swiping program for the first time to update the hashboard tester control board FPGA, unzip it and copy it to the SD card, and then insert the card into the hashboard tester card slot; power on for about 1 minute and wait for the control board indicator to double flash 3 times, then the update is completed; (if it is not updated, it may cause a certain chip to be bad during the test)

Zynq7007_sd_recover_nand_only_for_zhiju-0xB031

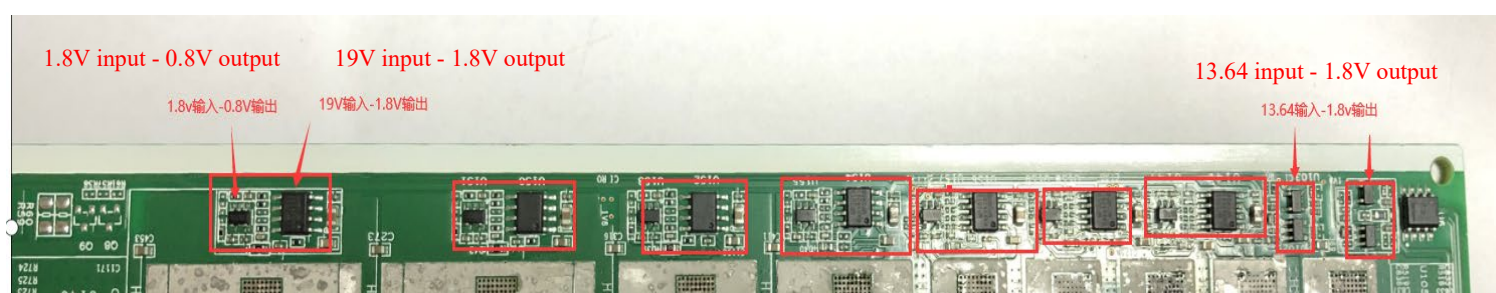
Figure 4-1

The hashboard is composed of 76 BM1398 chips, which are divided into 38 groups (domains), and each group is composed of 2 ICs; the operating voltage of the BM1398 chip used in the S19 hashboard is 0.36V; for the 38th, 37th, 36th, 35th, 34th, 33rd, 32nd group (7 groups in total), LDO is powered by the 19V output from the boost circuit U9 and outputs 1.8V. The 31st group - the first group are supplied by VDD13.64V through the LDO to provide 1.8V, and the voltage of each domain retreated is reduced by 0.36V. All 0.8V is provided by the 1.8V output of this domain via LDO, as shown in Figure 4-1;

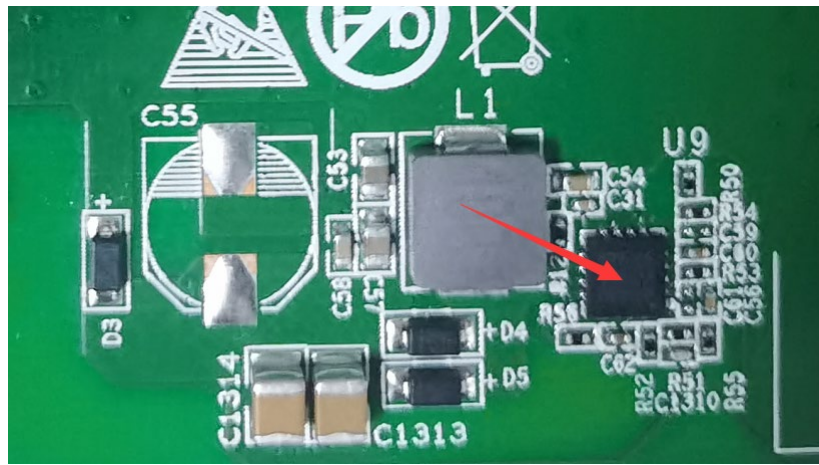
Figure 4-5

The boost circuit transfers the 14V powered by the power supply to 19V, as shown in Figure 4-5.

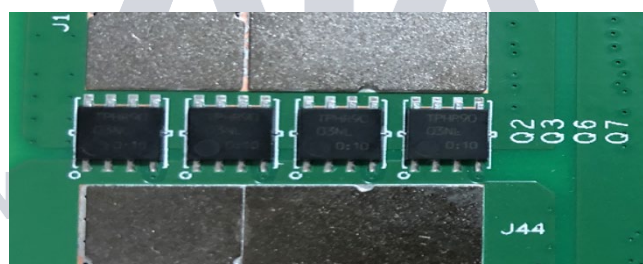
Figure 5-2

Second step: to check the voltage output in the voltage domain

The voltage of each voltage domain is about 0.36V. If there is 14V power supply, generally it has domain voltage. The priority is given to measure the output of the power supply terminal of the hashboard and whether the MOS is short-circuited (measure the resistance between pins 1, 4 and 8). If 14V has power supply but no domain voltage, continue to check.

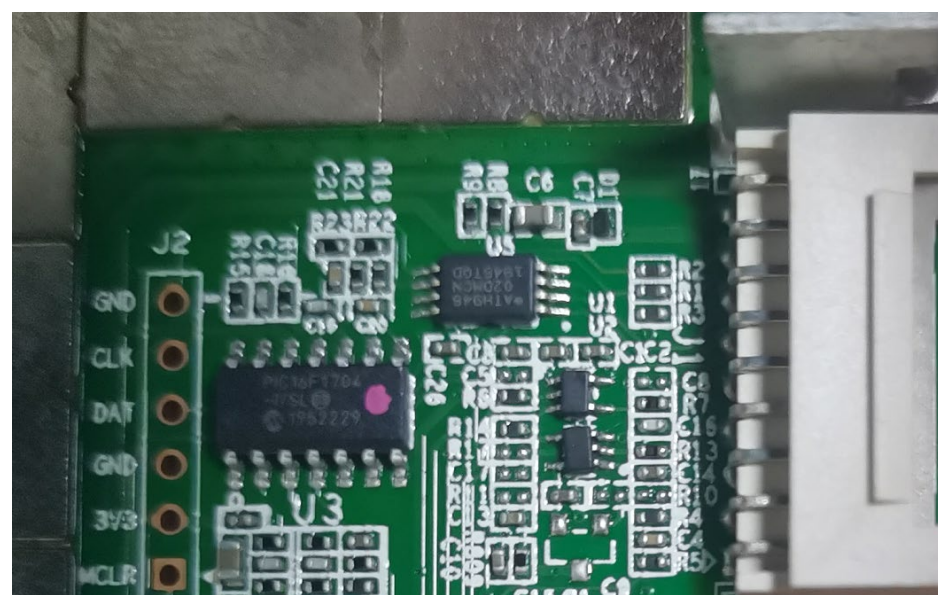
Figure 5-3

Measure whether there is output on the second pin of U3 and the voltage is about 3.3V; if yes, please continue to troubleshoot the problem; if there is no 3.3V, please check the connection status of the hashboard tester cable and the hashboard is OK, and reprogram the PIC.

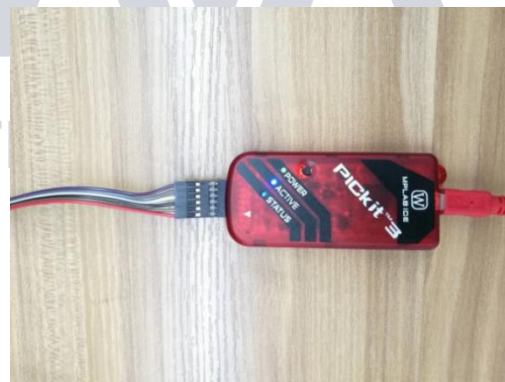
Figure 5-6

Download the programming tool: PICKit3, pin 1 of the PICKit3 cable corresponds to pin 1 of J2 on the PCB, and pins 1, 2, 3, 4, 5, and 6 need to be connected.

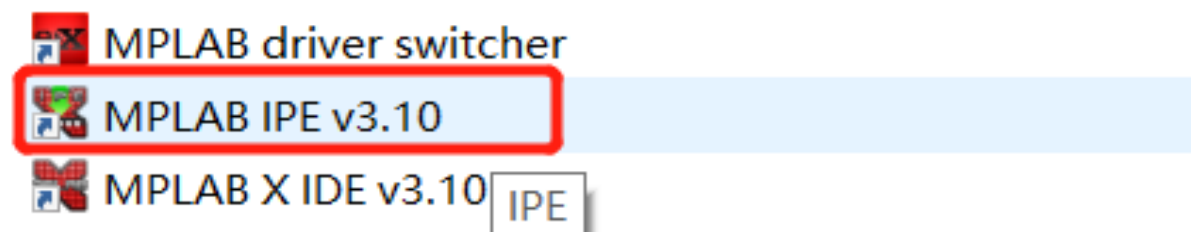
Figure 5-7

Open MPLAB IPE and select device: PIC16F1704, click power to select the power supply mode, then click operate. The first step: select file to find the .HEX file to be programmed; the second step: click connect to connect normally; the third step: click the program button, and after completion, click verify to prompt the verification to prove that the programming is successful.

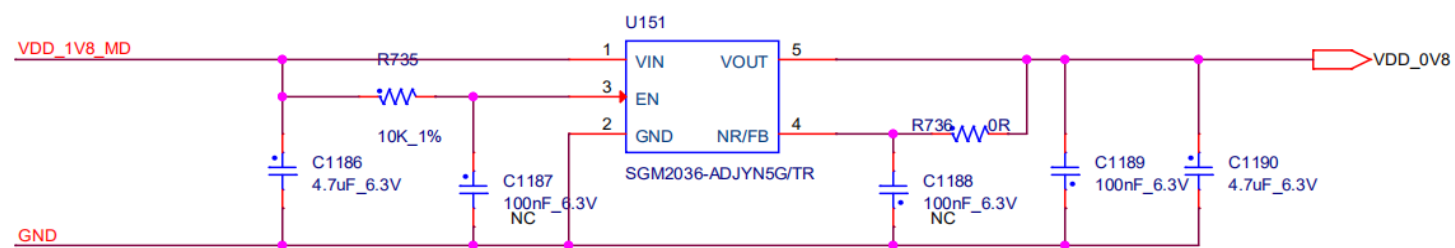
Figure 5-11

Fifth step: check the output of each group of LDO 1.8V or PLL 0.8V

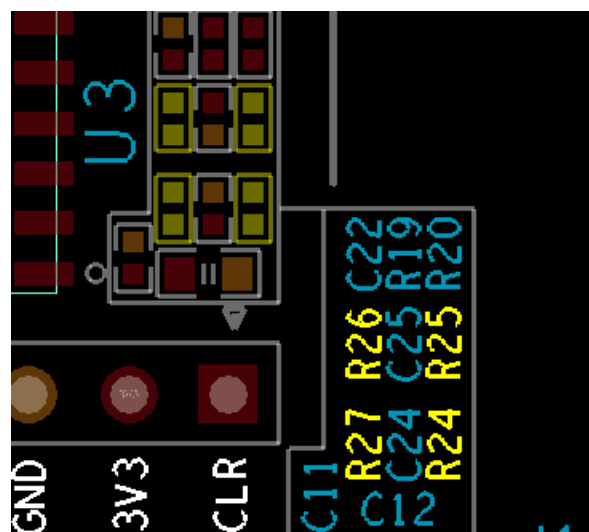
Figure 5-13

A) Check whether the 4 resistors of R24~R27 are welding abnormally, and check whether the welding of PIN2, 3 of U3 is normal;

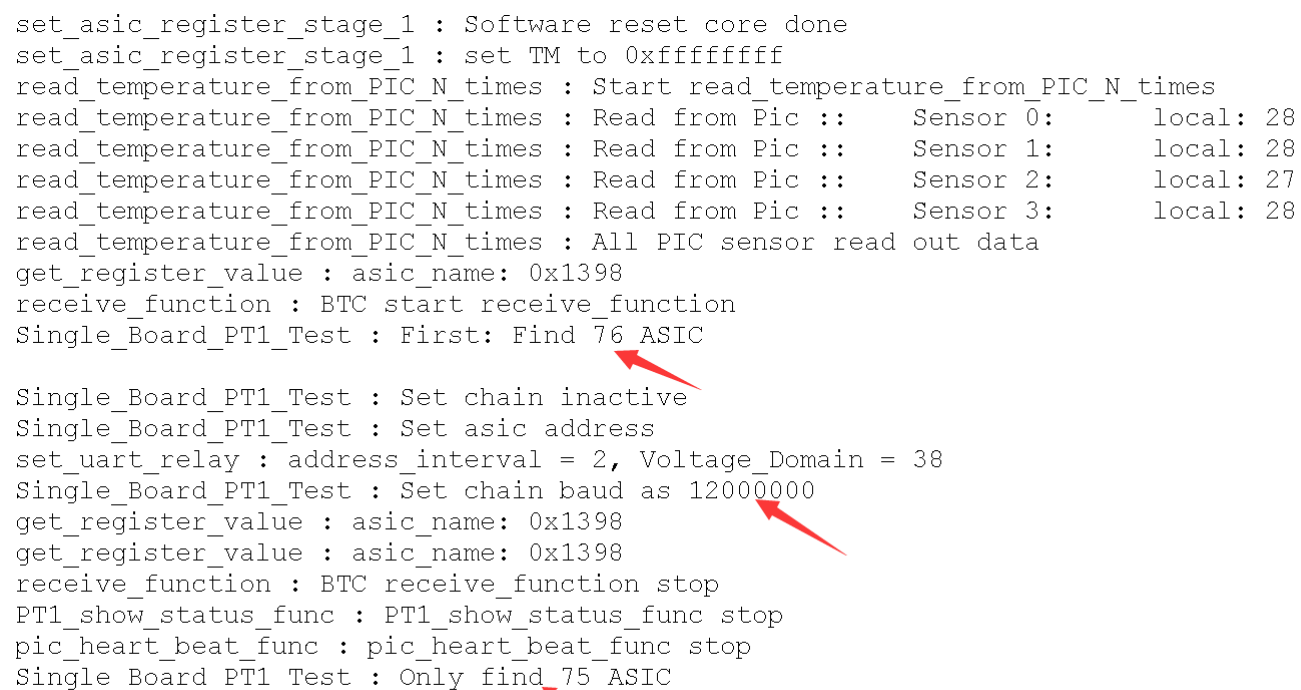
Figure 5-15

c) LCD display ASIC75: (Reporting 75), it means that the hashboard can detect 76 chips at 115200 baud rate, but only 75 chips are found at 12M baud rate, and one chip could not find at 12M baud rate;

Repair method: Using the dichotomy method, short-circuit the 1V8 test point and the RO test point between the 38th and 39th chips through the short-circuit probe. If the log can find 38 chips, there is no problem with the first 38 chips; if short-circuiting 47 chips, but the log reports 46, it indicates that the 47th chip cannot be detected, and there is no problem with the visual inspection. Generally, the 47th chip shall be replaced;

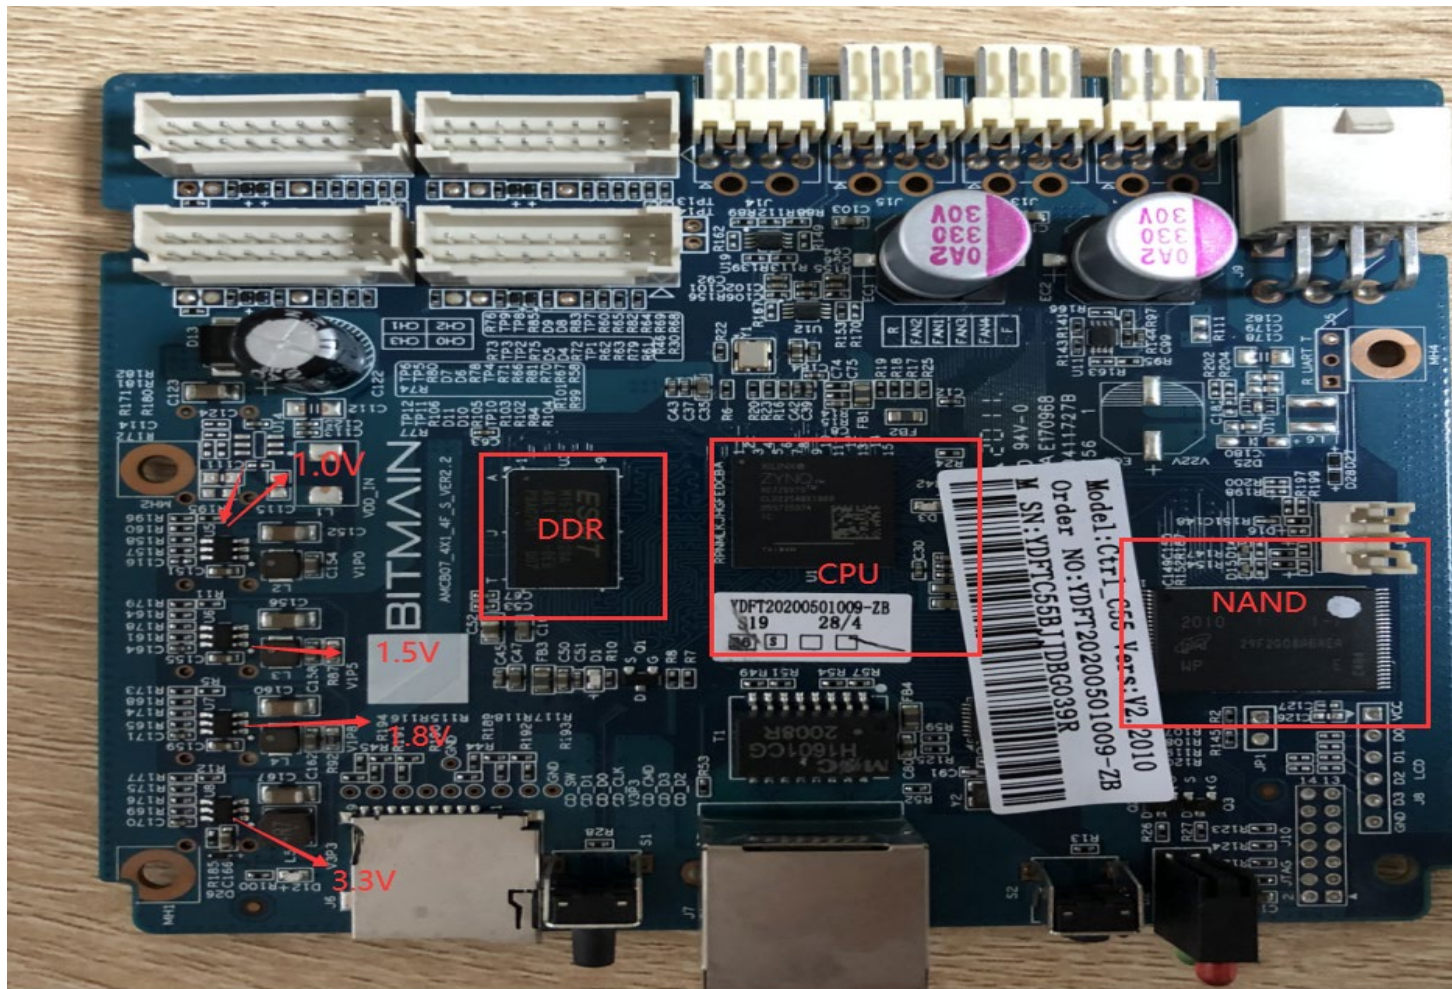
Figure 6-1

(1) Sudden power failure during OTP or time of less than 30s will cause the control board to fail to open the OTP function. As for the issue that the control board cannot start (not networked), the user needs to replace the U1 (main control IC FBGA of control board). U1 can no longer be used in 19 series after replacement

(2) For the control board with OTP function turned on, U1 cannot be used on other series of models;

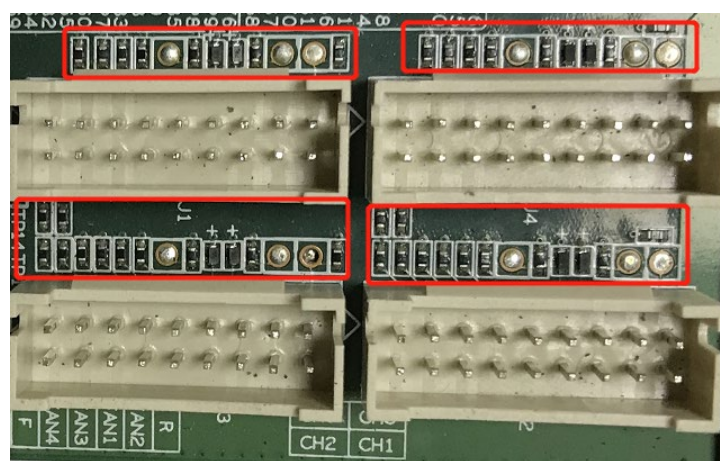
Figure 6-2

- Check the cable connection status.
- Check the parts of the control board corresponding to the chain.
- Check the wave soldering quality of the plug-in pins and the resistance around the plug-in interface.

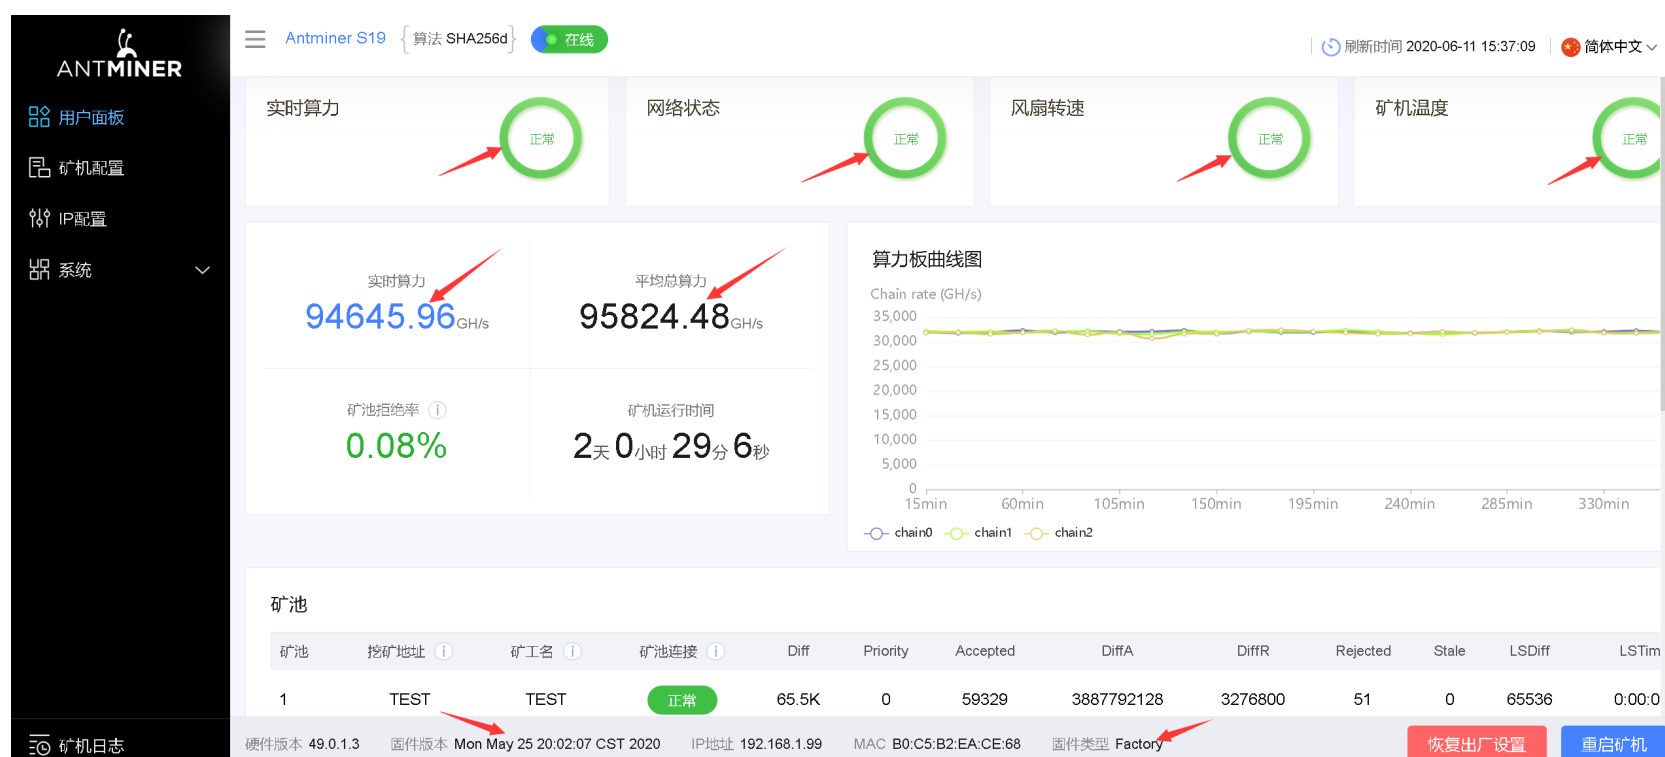
Figure 7-3

- 6) Test status of normal miner;

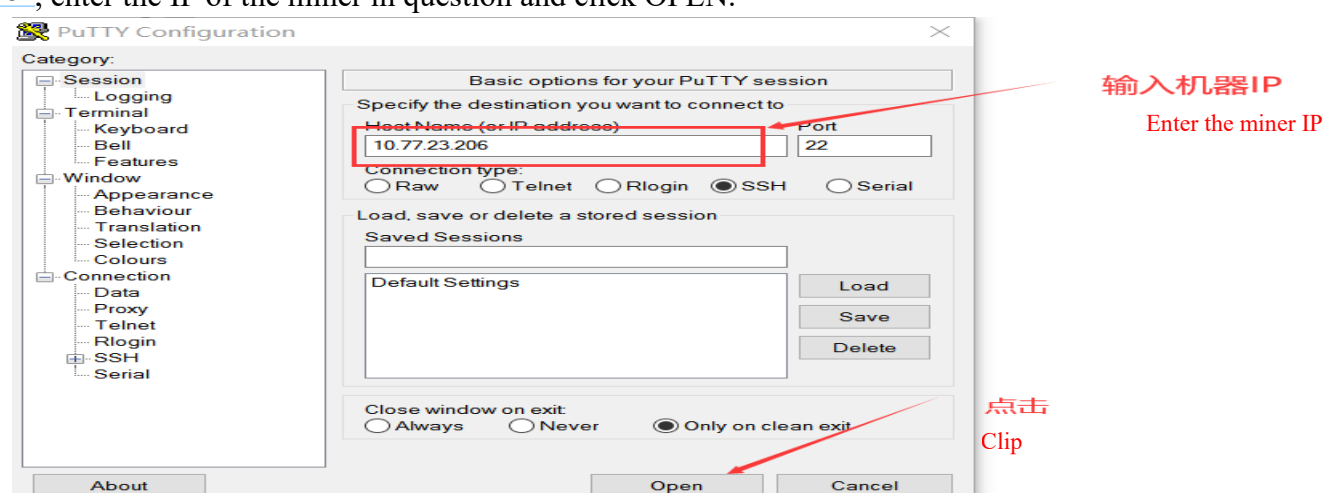
Figure 7-5

1. Open , enter the IP of the miner in question and click OPEN.

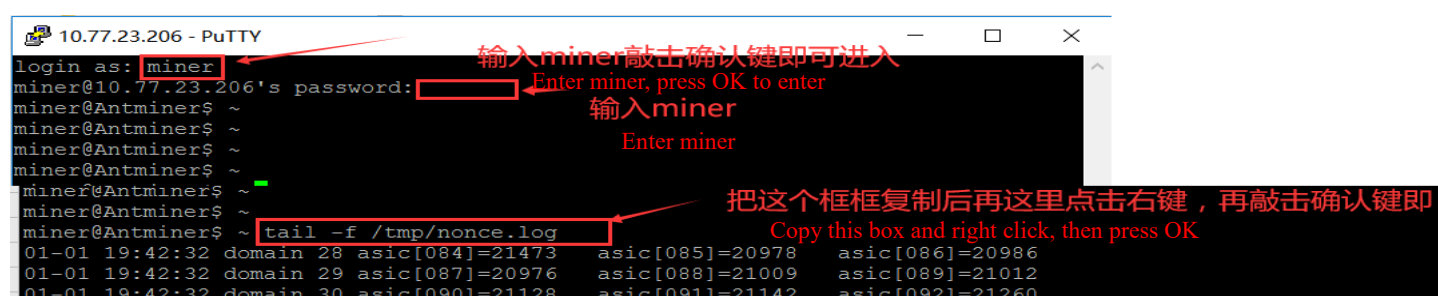
Figure 7-6

2. Enter the user name, password and test command to check the NONCE response status and the status of voltage domain. If the NONCE and domain voltage are abnormal, user can perform measurement and maintenance based on the printed abnormal chip.
