I. Maintenance Platform/Tool/Equipment Preparation Requirements

1. Working structure of S19 Pro hashboard:

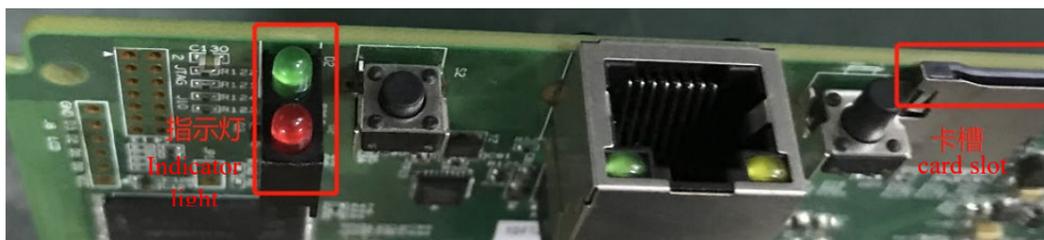
Figure 3-1

1. Use the 19 series hashboard tester SD card reflash program for the first time to update the hashboard tester control board FPGA, unzip it and copy it to the SD card, and then insert the card into the hashboard tester card slot; power on for about 1 minute and wait for the control board indicator to double flash 3 times, then the update is completed; (if it is not updated, it may cause a certain chip to report fault during the test)

Zynq7007_sd_recover_nand_only_for_zhiju-0xB031

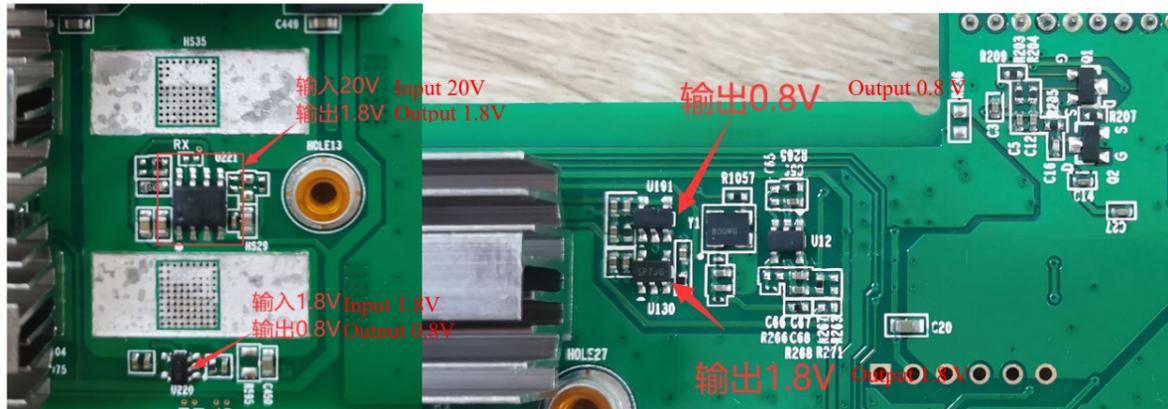
Figure 4-1

The hashboard is composed of 114 BM1398 chips, which are divided into 38 groups (domains), and each group is composed of 3 ICs; the operating voltage of the BM1398 chip used in the S19 Pro hashboard is 0.32V; for the 38th, 37th, 36th, 35th, 34th, 33rd, 32nd group (7 groups in total), LDO is powered by the 19V output from the boost circuit Q9 and outputs 1.8V. The 31th group - the first group are supplied by VDD12.6V through the LDO to provide 1.8V, and the voltage of each domain retreated is reduced by 0.32V. All 0.8V is provided by the 1.8V output of this domain via LDO, as shown in Figure 4-1;

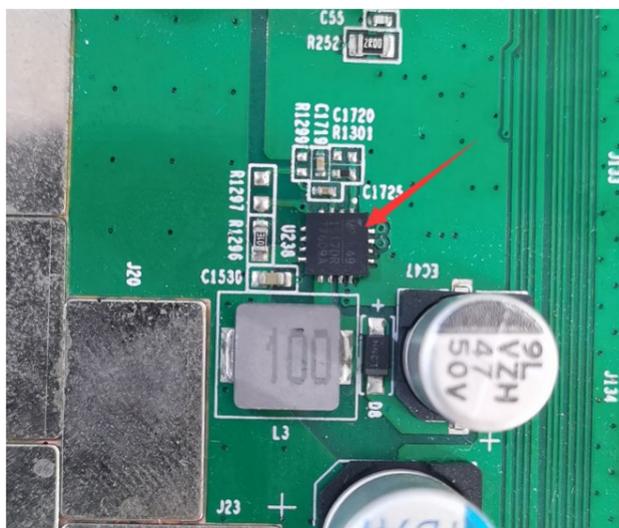
Figure 4-5

2. S19 Pro hashboard boost circuit:

The boost circuit transfers the 12.6V powered by the power supply to 20V, as shown in Figure 4-5.

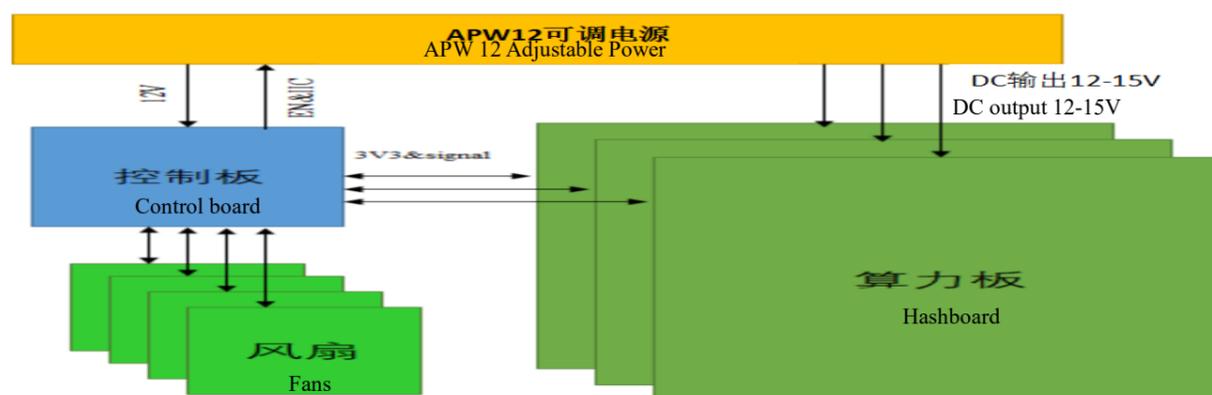
Figure 4-6

4. Whole miner architecture:

The whole miner is mainly composed of 3 hashboards, 1 control board, APW12 power supply, and 4 cooling fans, as shown in Figure 4-6.

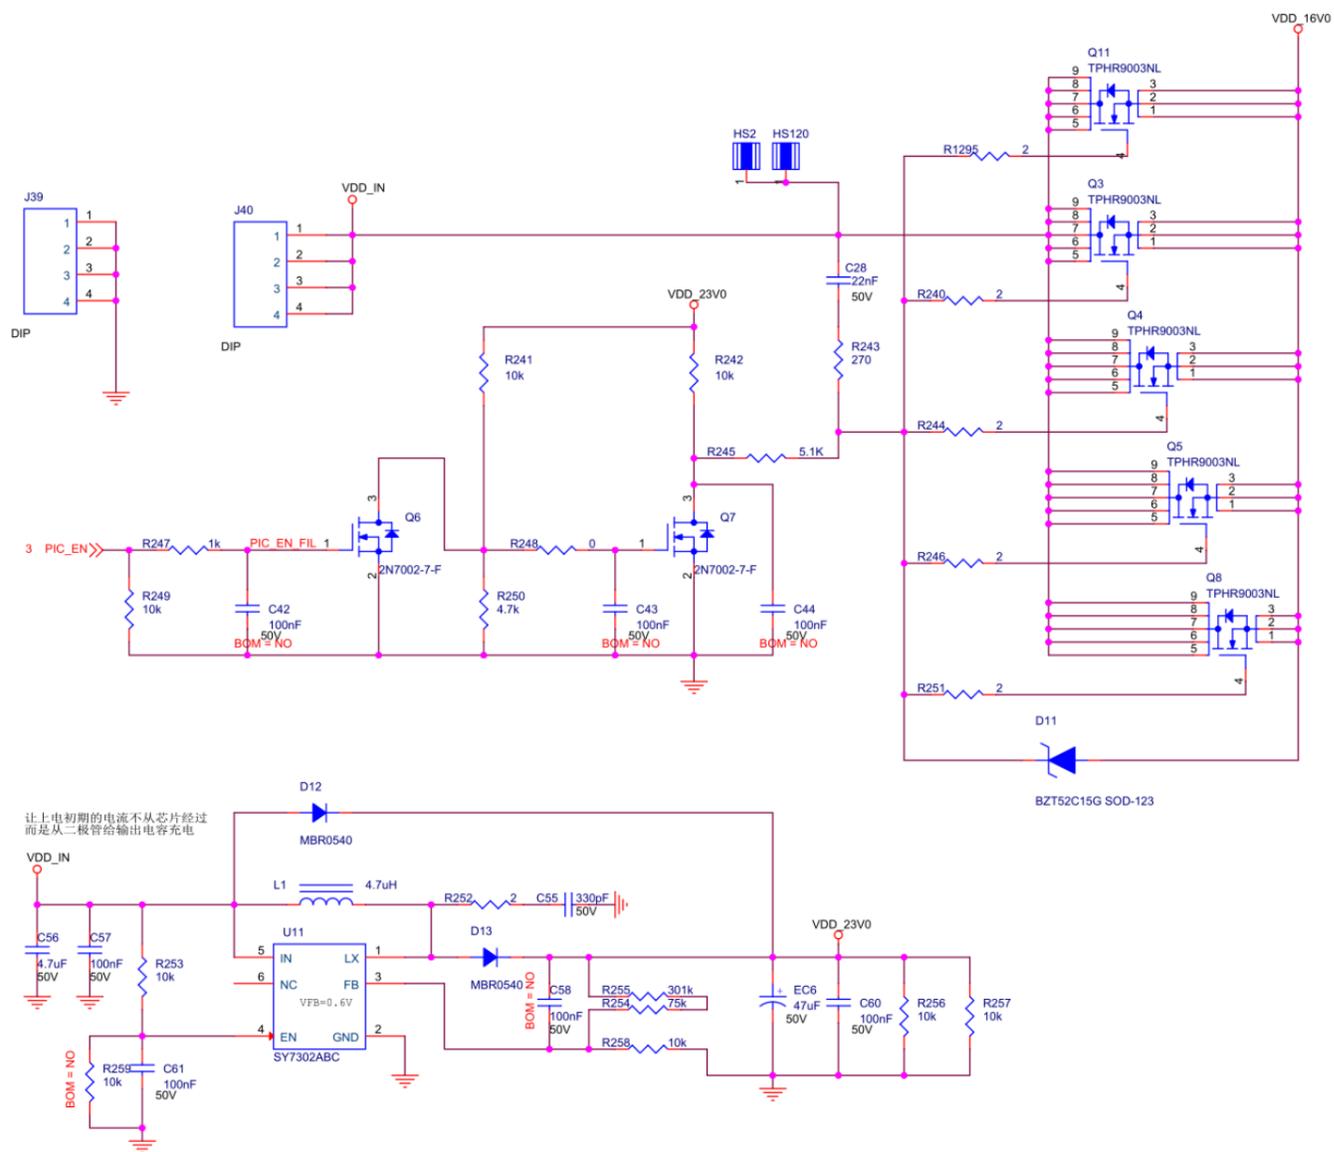
Figure 5-1

Step 1: check the power output first, please check the Figure 5-1.

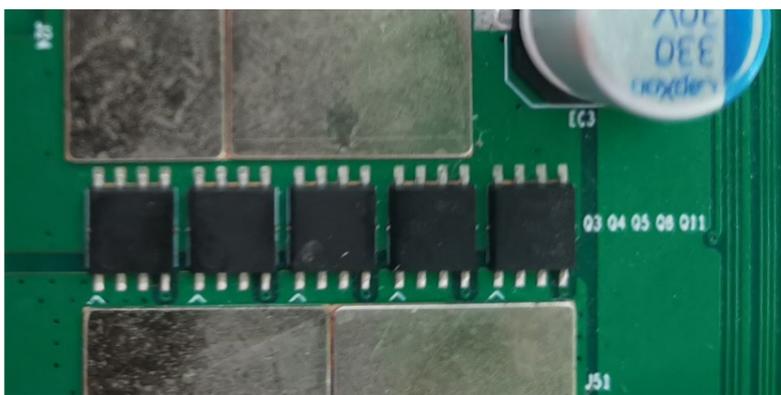
Figure 5-2

Step 2: to check the voltage output in the voltage domain

The voltage of each voltage domain is about 0.32V. If there is 16V power supply, generally it has domain voltage. The priority is given to measure the output of the power supply terminal of the hashboard and check whether the MOS is short-circuited (measure the resistance between pins 1, 4 and 8). If 16V has power supply but no domain voltage, continue to check.

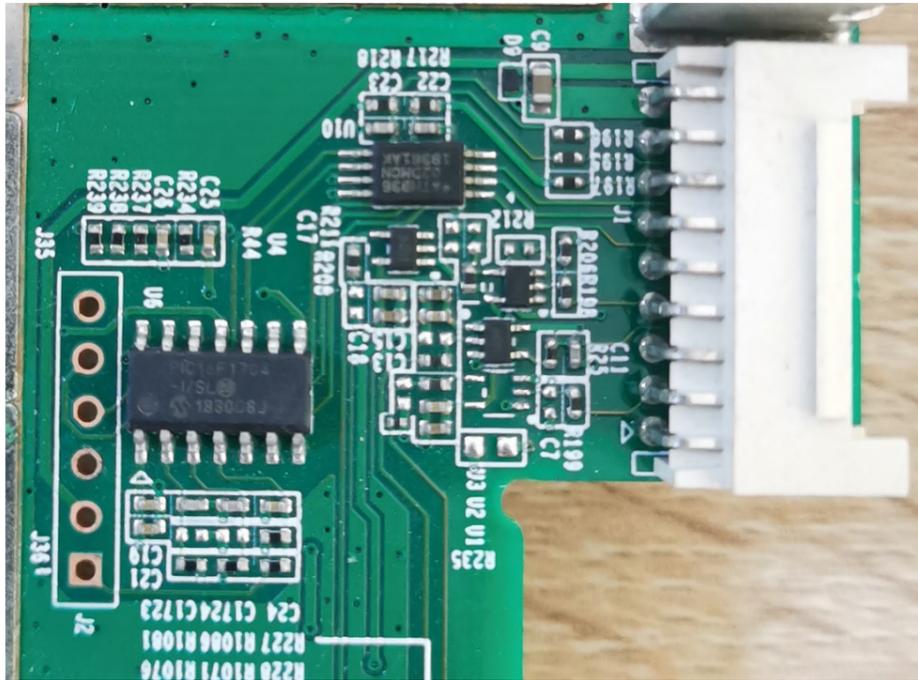
Figure 5-3

Step 3: to check the PIC circuit

Measure whether there is output on the second pin of U6 and the voltage is about 3.3V; if yes, please continue to troubleshoot the problem; if there is no 3.3V, please check the connection status of the hashboard tester cable and the hashboard is OK, and reprogram the PIC.

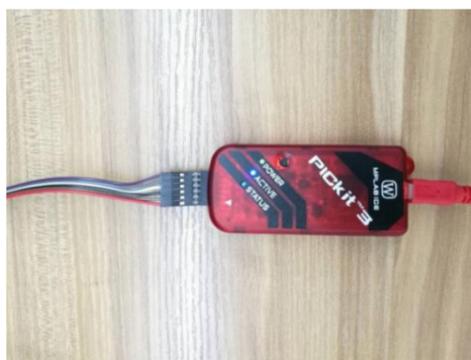
Figure 5-5

Download the programming tool: PICKit3, pin 1 of the PICKit3 cable corresponds to pin 1 of J2 on the PCB, and pins 1, 2, 3, 4, 5, and 6 need to be connected.

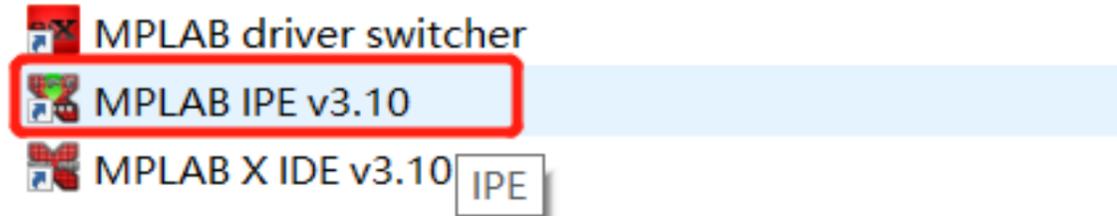
Figure 5-6

Open MPLABIDE and select device: PIC16F1704, click power to select the power supply mode, then click operate. The first step: select "file" to find the .HEX file to be programmed; the second step: click "connect" to connect normally; the third step: click the "program" button, and after completion, click "verify" to prompt the verification to prove that the programming is successful.

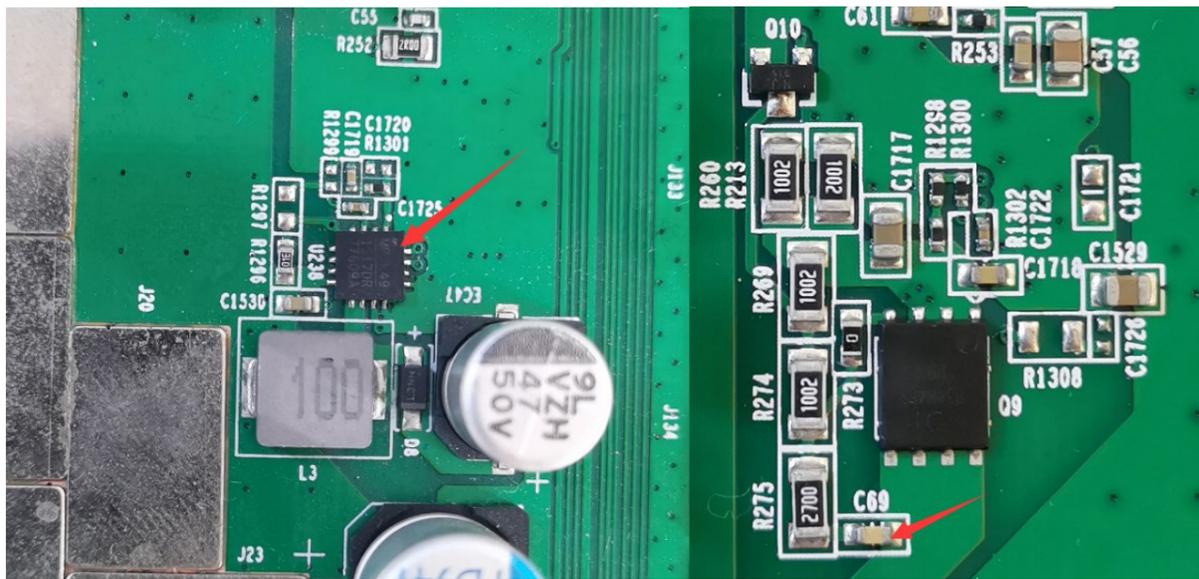
Step 4: check the boost circuit output, C69 in the Figure 5-8 can measure 20V voltage.

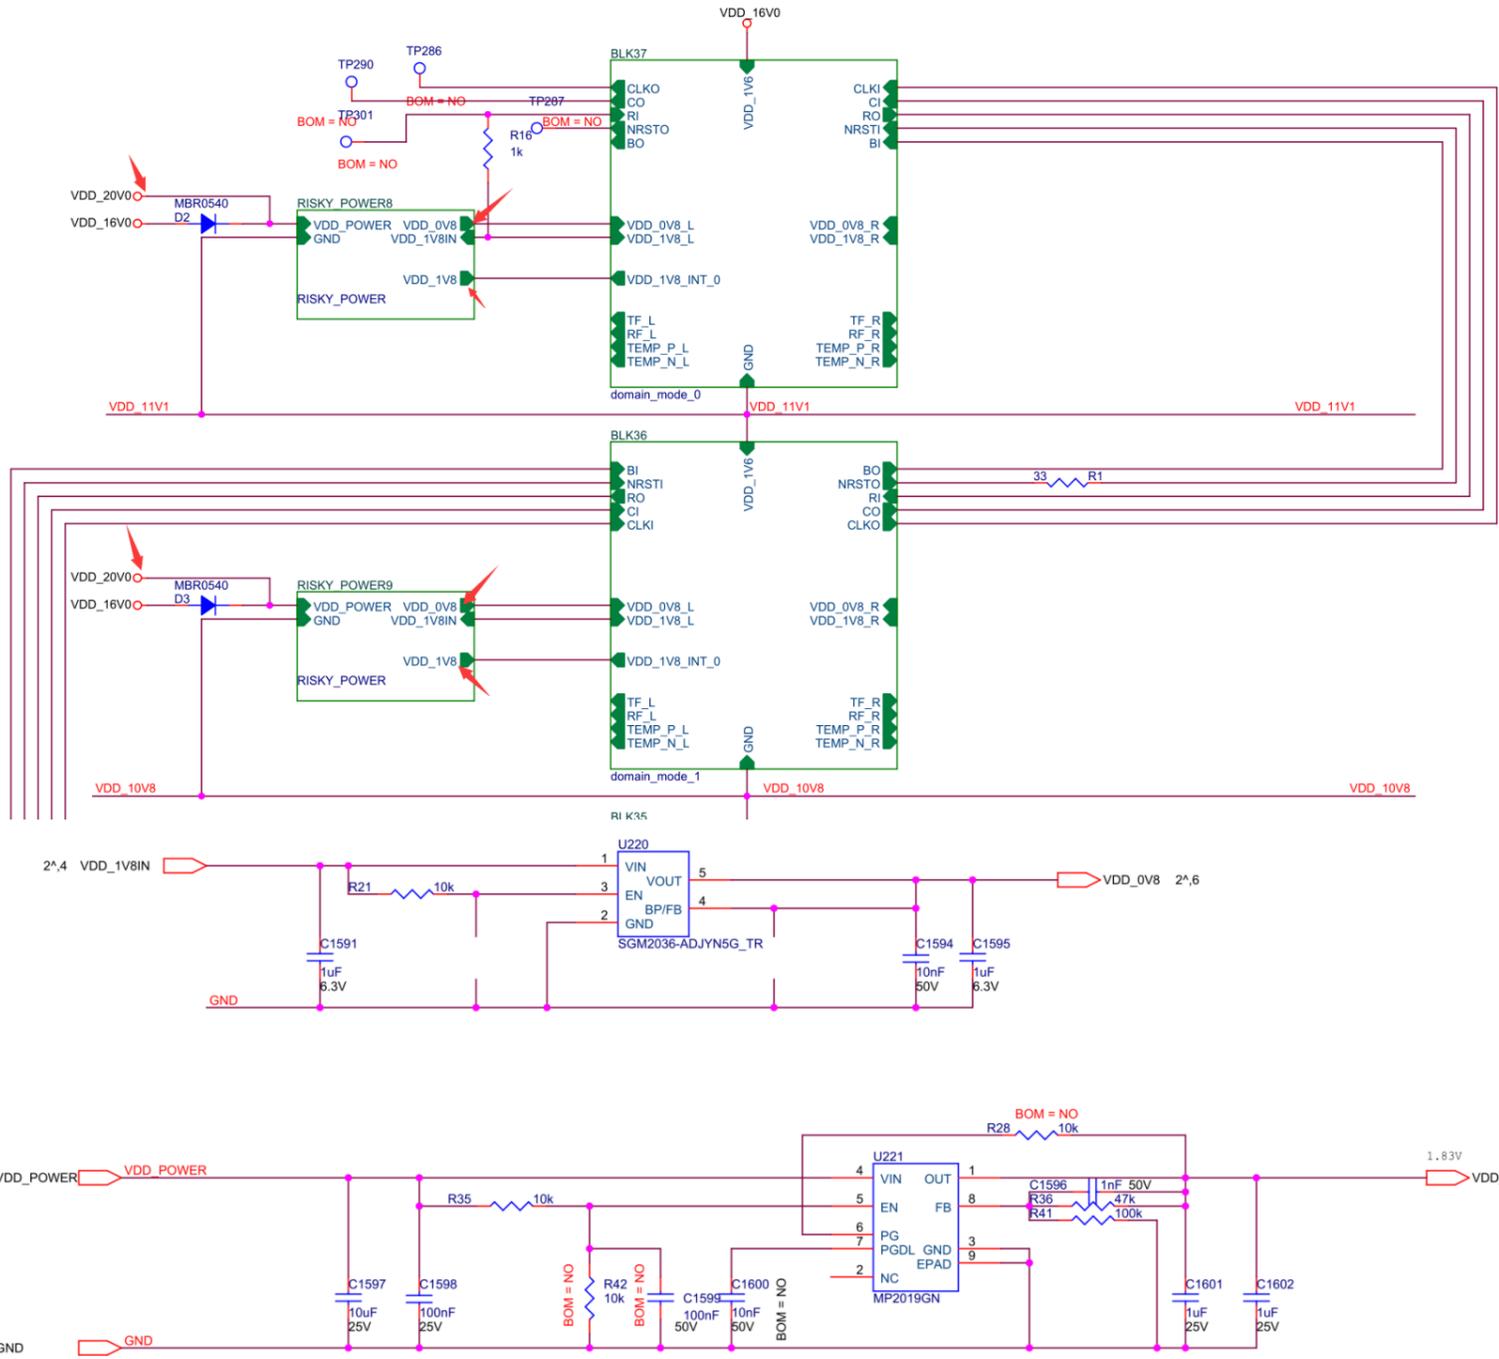
ANT TRAINING ACADEMY Figure 5-10

Step 5: check the output of each group of LDO 1.8V or PLL 0.8V

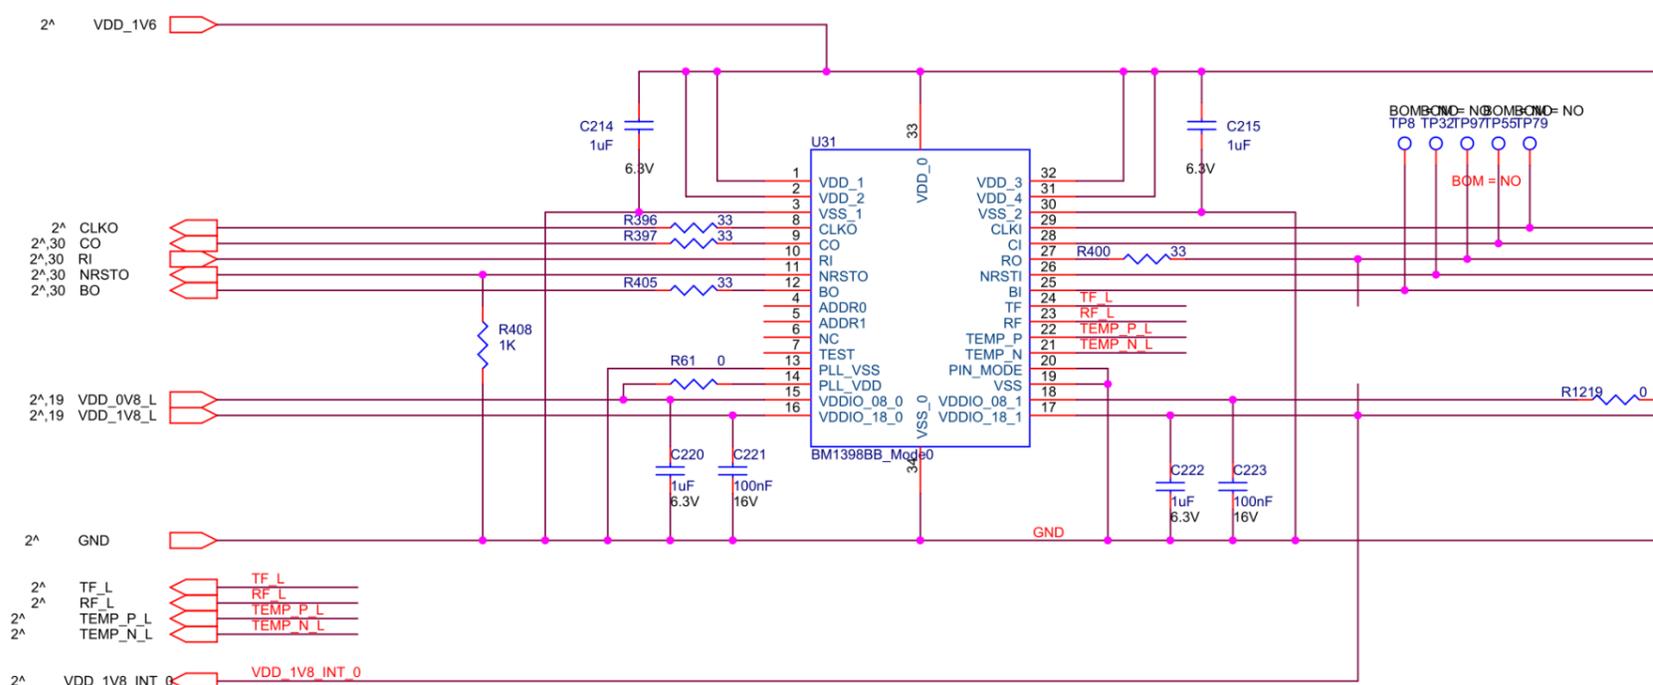
Figure 5-12

Step 6: check the chip signal output (CLK/CI/RI/BO/RST)

Refer to the voltage value range described by the signal trend. If the measurement encounters a large deviation of the voltage value, it can be compared with the measured value of the adjacent group to determine.

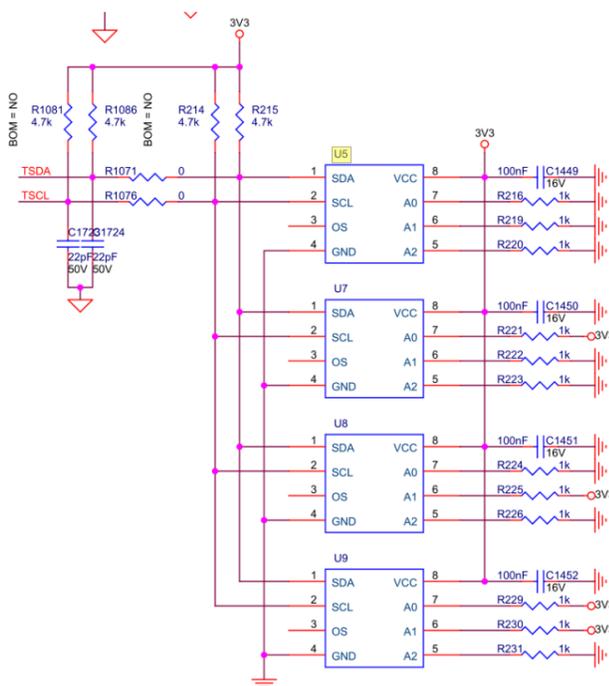
Figure 5-13

B) Check whether the four temperature sensors of U5, R216、R219、R220, U7, R221~R223, U8, R224~R226, U9, R229~R231 and the matching resistance welding are abnormal, the location of the temperature sense is as shown in Figure 4-4 and 5-13, the temperature sensor is all located on the back of the PCB, the resistance is located on the front and back of the PCB, and whether the temperature sensor 3.3V power supply is normal; Check the welding quality of the chip which connects sensor and the small heat sink. The deformation of large heat sink material will cause poor heat dissipation of the chip and affect the temperature difference.

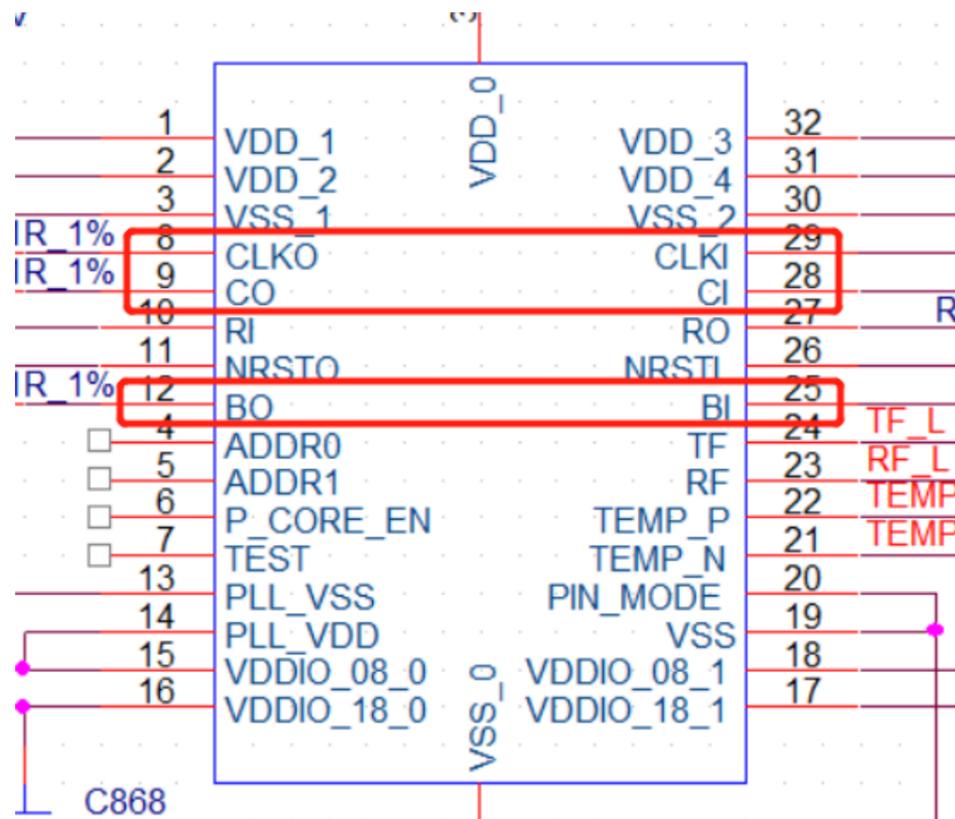
Figure 5-16

d-1) The first case: the test time is basically the same as the good board (usually the value of X will not change each time you test) (test time refers to the time from when the start test button is pressed to the time when the result of ASICNG: (X) is displayed on the LCD). This situation is likely to be caused by the abnormal resistance welding of the front and rear CLK, CI, and BO of the Xth chip, so users shall focus on these 6 resistors. The small probability is due to X-1, X, X+1, that is, among the three chips, the following pins abnormal welding conditions of the chip occur:

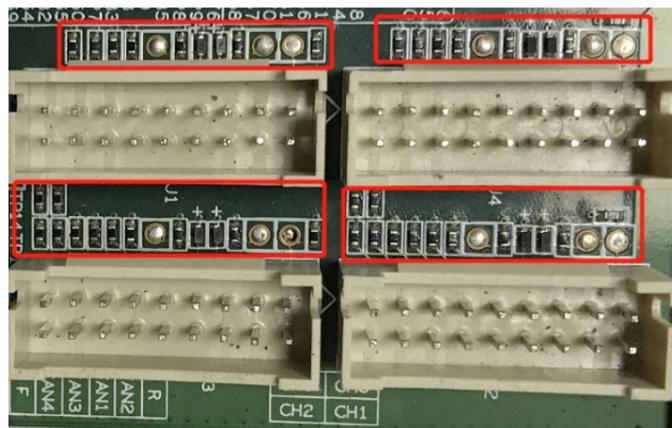
Figure 6-2

4. The whole miner fails to load the hashboard or has less links

- A. Check the cable connection status.
- B. Check the parts of the control board corresponding to the chain.
- C. Check the wave soldering quality of the plug-in pins and the resistance around the plug-in interface.

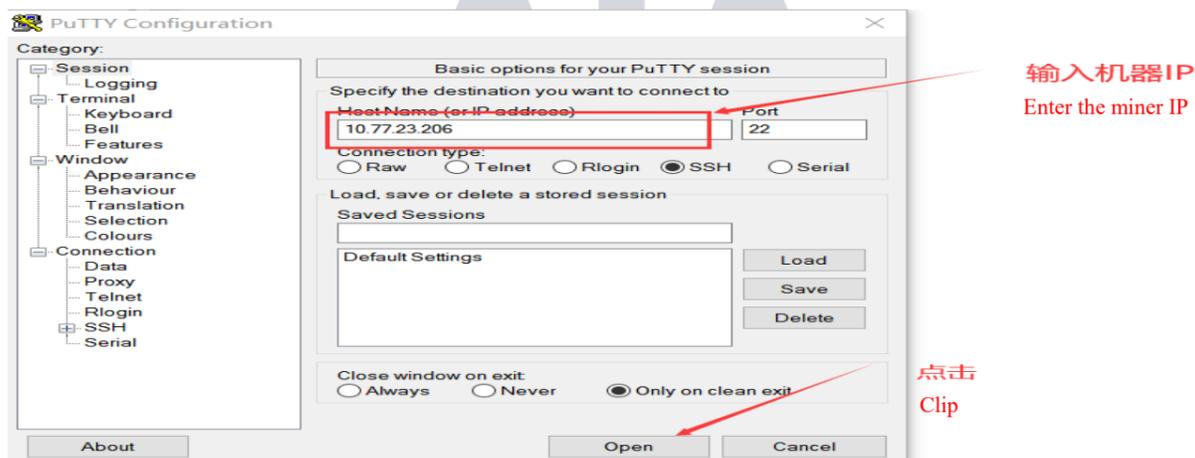
Figure 7-5

1. Open , enter the IP of the miner in question and click OPEN.

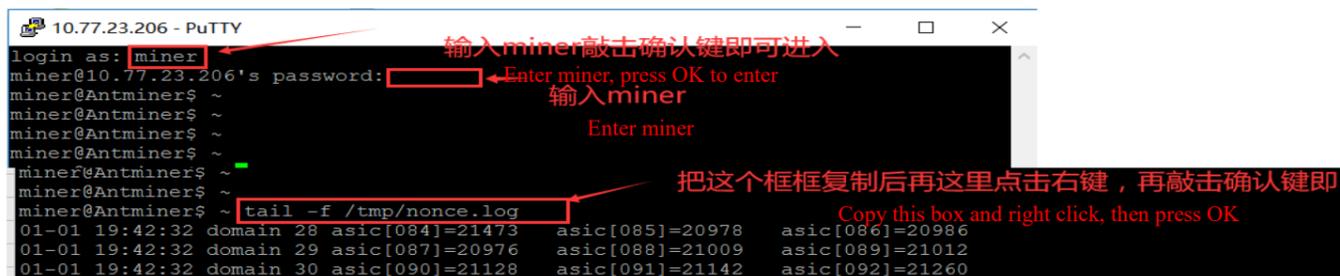
Figure 7-6

2. Enter the user name, password and test command to check the NONCE response status and the status of voltage domain. If the NONCE and domain voltage are abnormal, user can perform measurement and maintenance based on the printed abnormal chip.

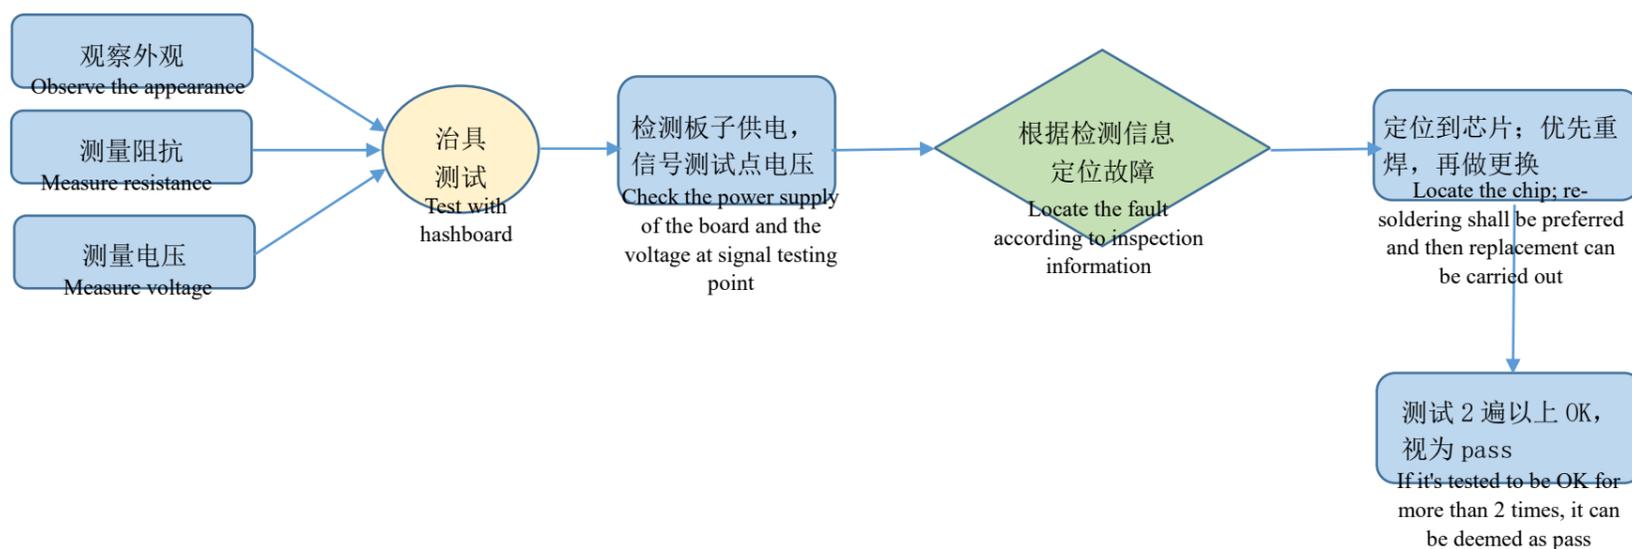
Figure 8-1 Maintenance flowchart

- Routine inspection: First, visually inspect the hashboard to be repaired, observe whether there is PCB deformation or scorching. If yes, it must be processed first; whether there are obvious burnt marks on the parts, collision offset parts or missing parts, etc.; secondly, after the visual inspection is passed, the impedance of each voltage domain can be tested first to detect whether there is a short circuit or an open circuit. If yes, it must be dealt with first. Furthermore, check whether the voltage of each domain is about 0.36V.

- After the routine test is passed (the short-circuit test of the general routine test is necessary to avoid the chip or other materials being burnt due to the short circuit when the power is turned on), the chip test can be performed with the hashboard tester, and the positioning can be determined according to the test result of the hashboard tester.
